DiamondWrap® HTA Restores Bath Heater to Safe Service

SUMMARY

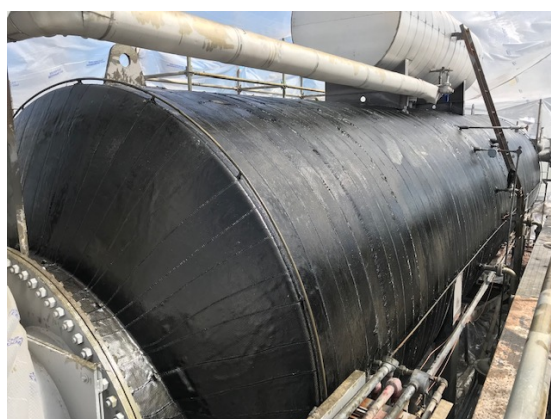
The flexibility and low profile of the DiamondWrap composite system allows installation even in areas with limited clearance.

With the decision made to use DiamondWrap to contain the damage, Liberty Sales & Distribution coordinated the contractor who deployed 2 technicians to the site to wrap the entire bath, which included the entire 10-foot diameter, 35-ft long unit, plus the domes on each end. The technicians prepared the surface and began applying two layers of the composite system, completing the project in 3 eight-hour shifts.

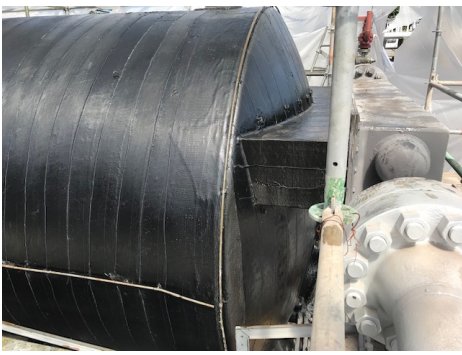
DiamondWrap can be installed on tees, elbows, and varied geometry without compromising the integrity of the repair. (Photo courtesy of ClockSpring|NRI)

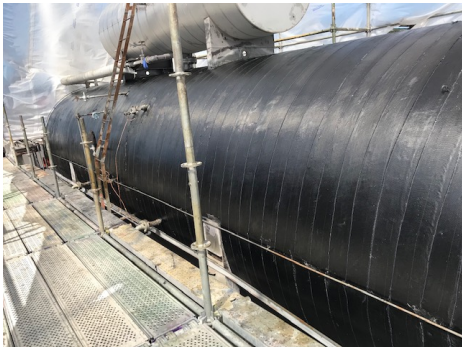
The composite system forms a pipe around a pipe, and each successive wrap increases the pressure rating, creating a finished repair that is stronger than steel. (Photo courtesy of ClockSpring|NRI)
