Polyethylene Repair Products - CRP-PE

CRP-PE Repair Patch for high-temperature polyethylene coated pipelines

Pipeline Repair Patch

CRP-PE Repair Patch

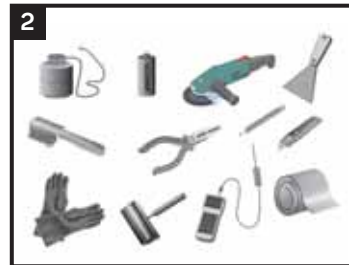
Equipment List

Propane tank, hose, torch & regulator; Appropriate tools for surface abrasion: grinder, 80-120 grit sandpaper; Appropriate tools for cleaning: rags & approved cleaner; Tools: roller, digital thermometer, knife, marker, measuring tape, scraper / spatula & pliers; Standard safety equipment; gloves, goggles, hard hat, etc.

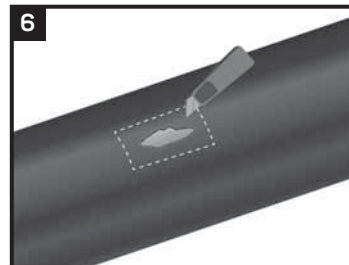
Major Repair: Exposed Metal

Using a knife, carefully cut out only the damaged coating into a smooth sided shape.
